ENGINEERING EVALUATION OF  
UH-1B HELICOPTER EQUIPPED WITH  
MODEL 540 ROTOR SYSTEM

PHASE B

FINAL REPORT

U. S. ARMY AVIATION TEST ACTIVITY  
EDWARDS AIR FORCE BASE, CALIFORNIA

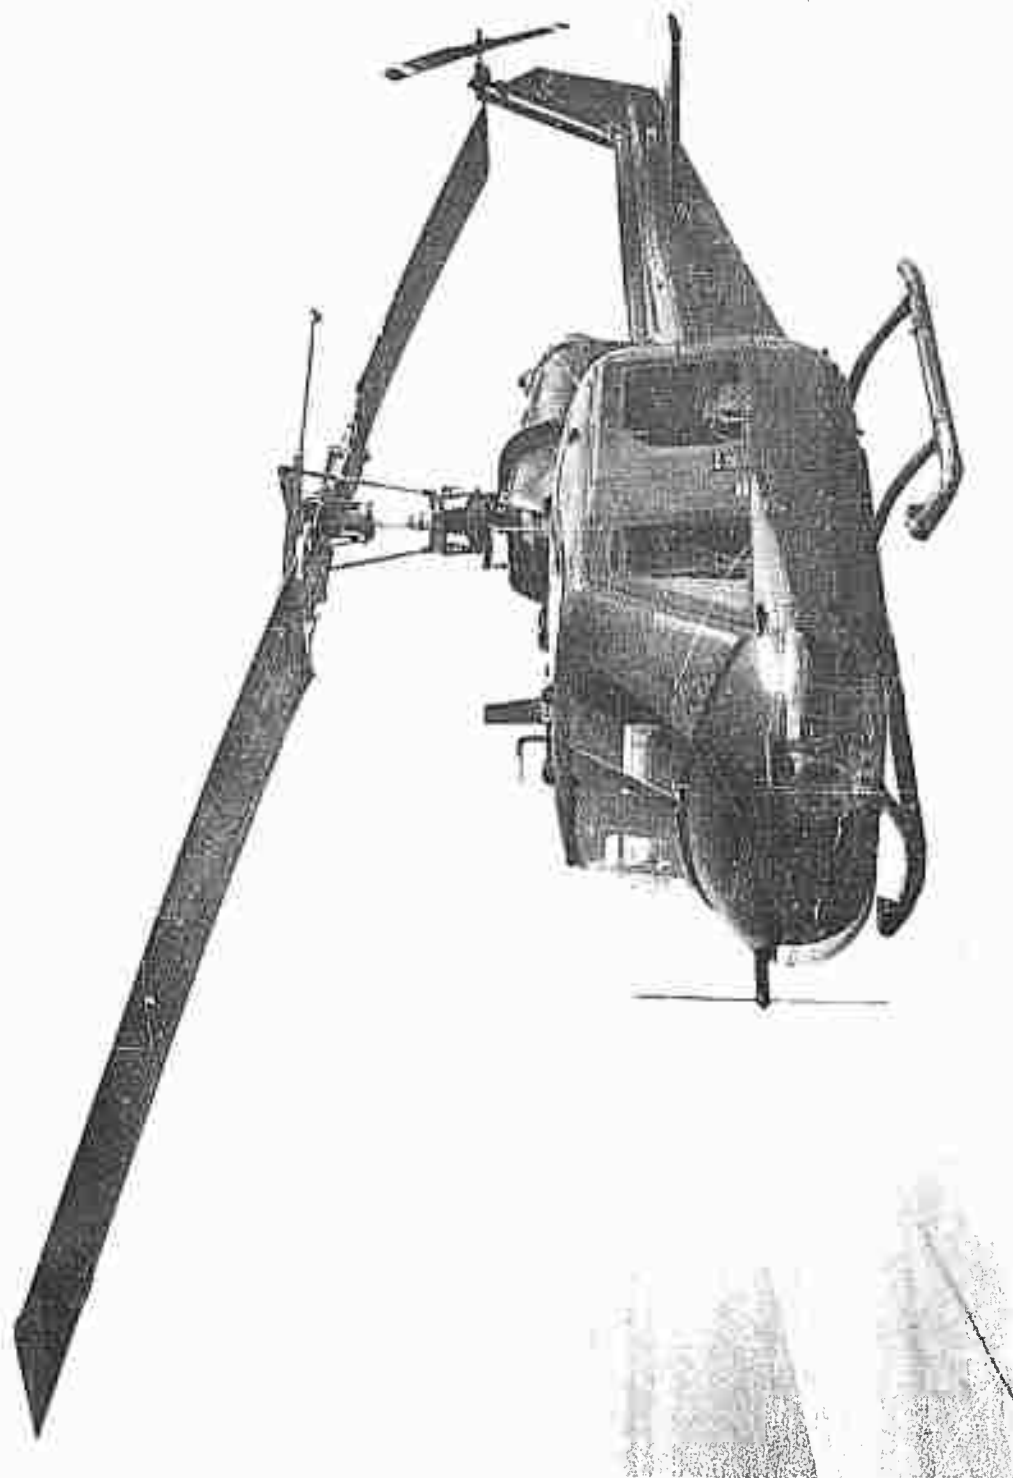
Photo No. 1 - UH-1B Helicopter equipped with model 540 rotor system
